**Green Pond Research and Demonstration Project:  
Aquatic Invasive Species Management  
2020 Final Report**  
December 26, 2020

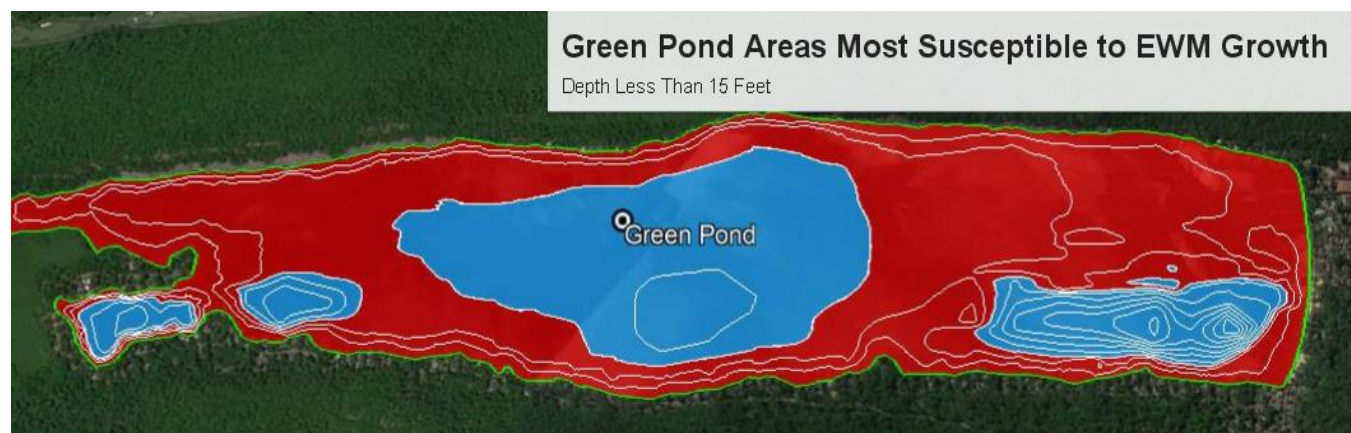
Areas Susceptible to EWM Growth **Red areas are depths less than 15 ft, most susceptible**  
Figure 2.1 **Blue Areas are deeper than 15 ft. less susceptible**

In a seven year span, the invasive plant species challenge in Green Pond grew from a single one acre area of Eurasian Watermilfoil (EWM) in 2013 to widely dispersed infestations in 174 acres which required closing the lake to boat traffic in 2019. At that time, EWM detected by sonar was present in 53% of the 330 acres hospitable to EWM growth in Green Pond.

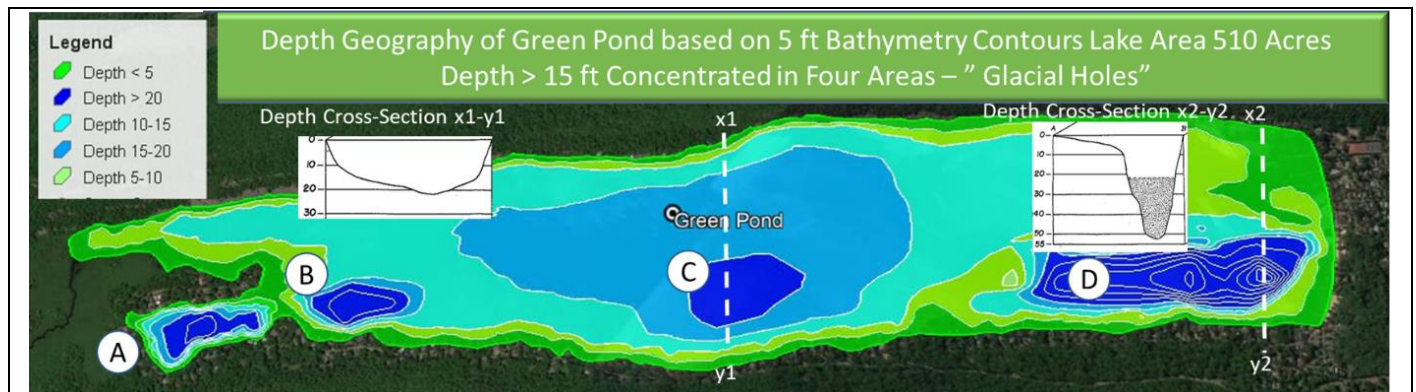
Figure 3.2: Bathymetry and depth cross sections show Green Pond’s classical glacial “hole” character

The approximate surveillance workload required in Green Pond can be seen from the bathymetry statistics shown in Figure 3.2. The question arose, what is the likely actual coverage potential? Green Pond has an acreage of 509 Acres, which does not include the outlet wetlands. Of that acreage, 168 Acres are between 10 and 15 feet deep. These depths have been the primary EWM habitat, although the bottom character and other factors make some parts less EWM habitable and some shallower areas have had significant EWM growth. Based on all factors, 330 acres were targeted to be inspected and cleared of any EWM.

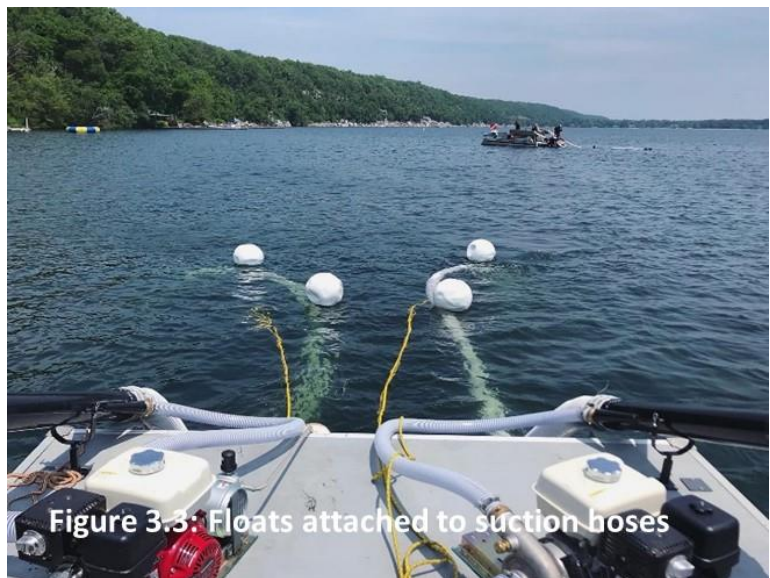
Figure 3.3: Floats attached to suction hoses

equipped with filters that removed moisture and particulates to help ensure clean air for breathing. In order to minimize environmental impact, a surface float (See Figure 3.3) would be attached to each ISR hose keeping the hose-end away from the lake bottom to prevent disturbing and/or removing of the lake bottom the sediment. In addition, to address the large infestations of EWM in New Jersey Highlands Region lakes, more removal capacity was required and achieved by doubling the normal removal power on the boat which allowed for double the normal level of divers to be in the water simultaneously. The resultant operation, consisting of two boats, four divers using four removal hoses during all work times, soon began demonstrating that a remarkably level of EWM and CLPW management could be achieved in this project.

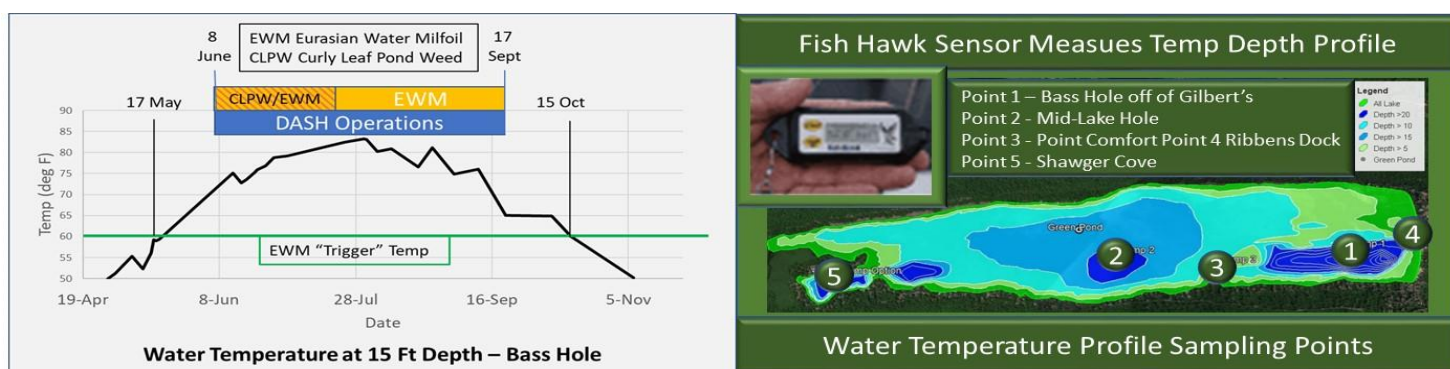
Figure 4.1 HIGLIN Water Temperature Measurement Program

A measurement program was established by HIGLIN to collect water temperature profile data and showed that the 10-15 foot depth reached the trigger temperature by May 21. See Figure 4.1. The next 10 degree increase at the 15 foot level lagged the surface temperature increase by 6 days. The deeper water temperatures follow the ground water temperature of about 55 degrees F and stayed stable over most of the summer, which causes the observed lag between shallower and deeper temperatures. Temperatures in shallower areas were showing about 2 weeks more time at 70 degrees than those at depth, and EWM present at shallower depth posed an early threat from interference by boating. In response to prevent boat traffic from fragmenting and spreading plants, a program of hand removal in shallow areas was begun on June 21, 2020. A more detailed explanation of temperature monitoring and results is given in Appendix A.

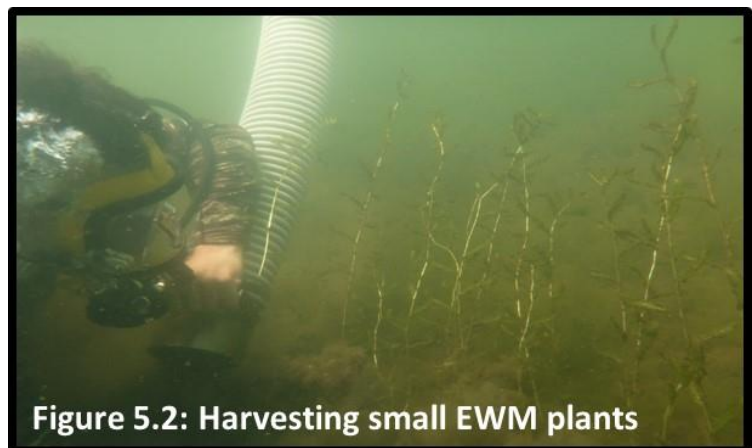
**Invasive Species Removal** The main method for removal, used in this project was hand removal assisted with ISR. Using five-inch diameter hoses attached to a Venturi system, two divers on each boat used a techniques to effectively remove invasive species found during an ISR survey. With small individual plants, the diver separates any root system from the sediment and introduces the plant into the opening of the removal hose as shown in Figure 5.2. For larger plants a similar technique was used starting at the top of the

plant and following it down to a point, where the diver reaches into the sediment and pulls out larger EWM roots. Some plants could also be removed by hand, and then brought back to the removal hose floating above the benthos with buoys. These techniques along with careful removal of invasive species lead to a very small number of native animals and foreign objects entering the Venturi system and minimal sediment. Anything that was brought onboard unintentionally ran back into the lake through sluice boxes or could be removed from the onion bags. Upon removing, aquatic plant material is transported by the removal hose to sluice boxes onboard and flows into 15" x 25" onion bags. Full of plant material, these bags on average ended up weighing approximately 25 pounds.

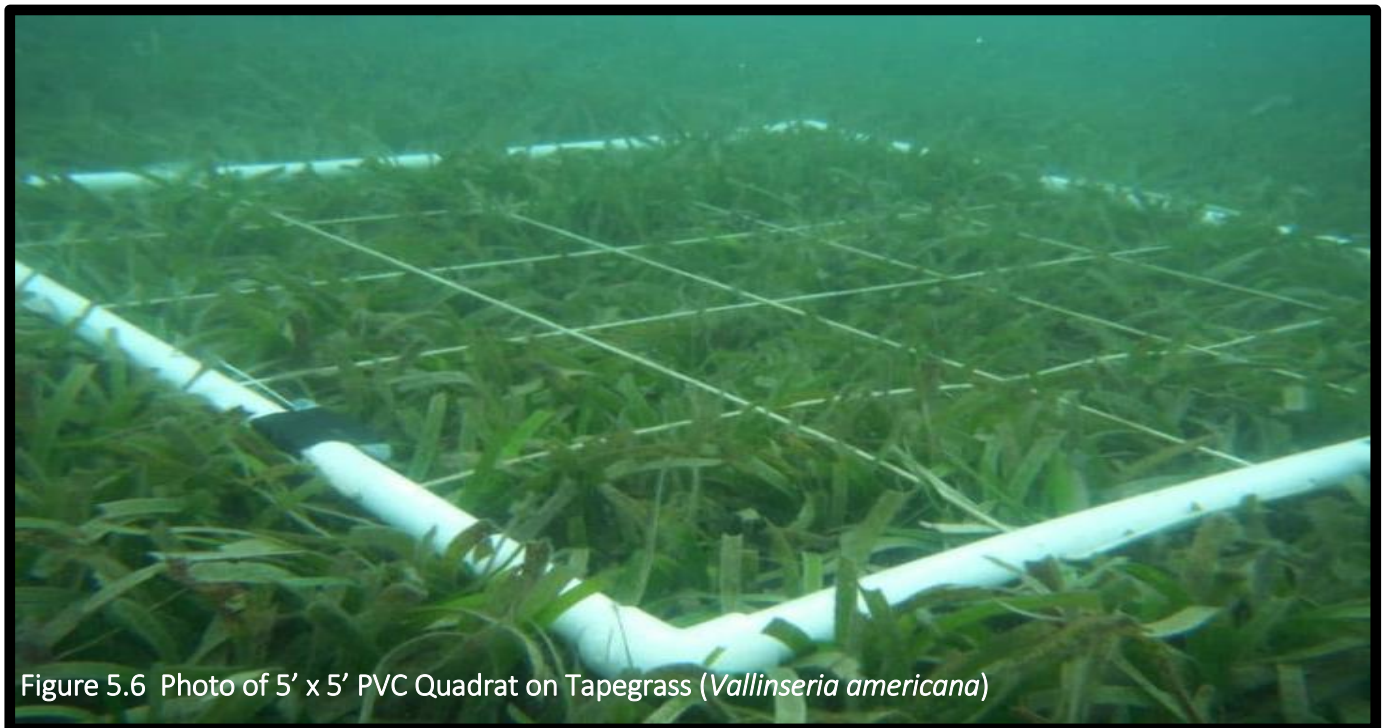
Figure 5.6 Photo of 5' x 5' PVC Quadrat on Tapegrass (*Vallisneria americana*)

Two techniques were used in this project. Fifty foot transects were conducted using underwater open reel tape measures, where each foot was surveyed for plant growth by two divers. This means each transect reported 100 points of data, with 25 transects recorded. Examples of plant counts from numerous samplings are shown in Appendix C. Quadrats (pictured in Figure 5.6) made of slim 5' x 5' PVC piping and a grid of 25 squares were also used to compare aquatic plant species by location and depth. Full results from all sampling are described in detail in Sections 6.2 and 6.3.

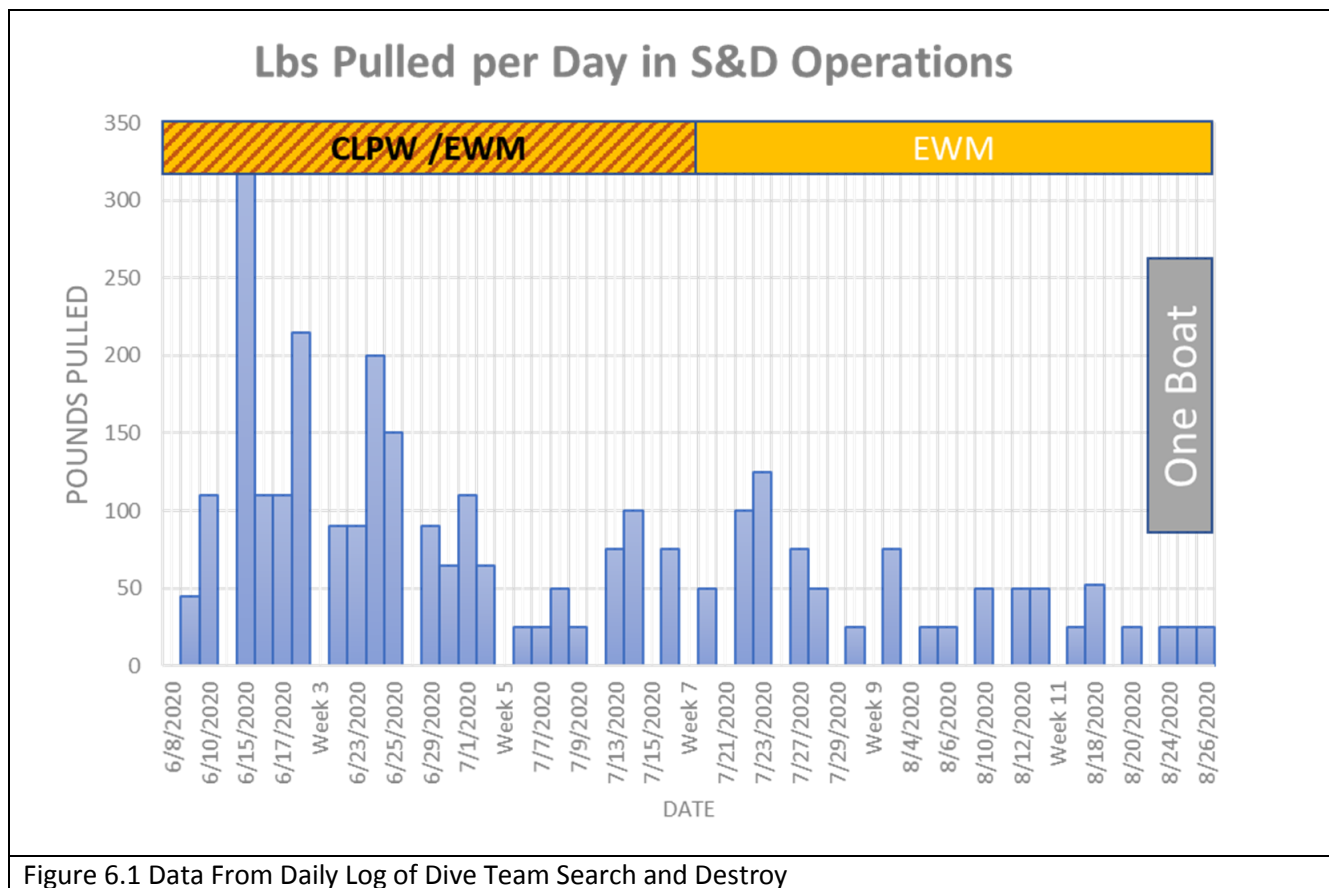
Figure 6.1 Data From Daily Log of Dive Team Search and Destroy

In the 2020 field season, a two ISR boat operation with two divers per boat continually in the water demonstrated the capacity to search out and clear 20 acres per day (10 acres per ISR boat per day). The keys factors in this were to start early and operate consistently to identify and remove invasive species as it emerged and before it could form the dense clusters that could only be cleared at a much slower rate.

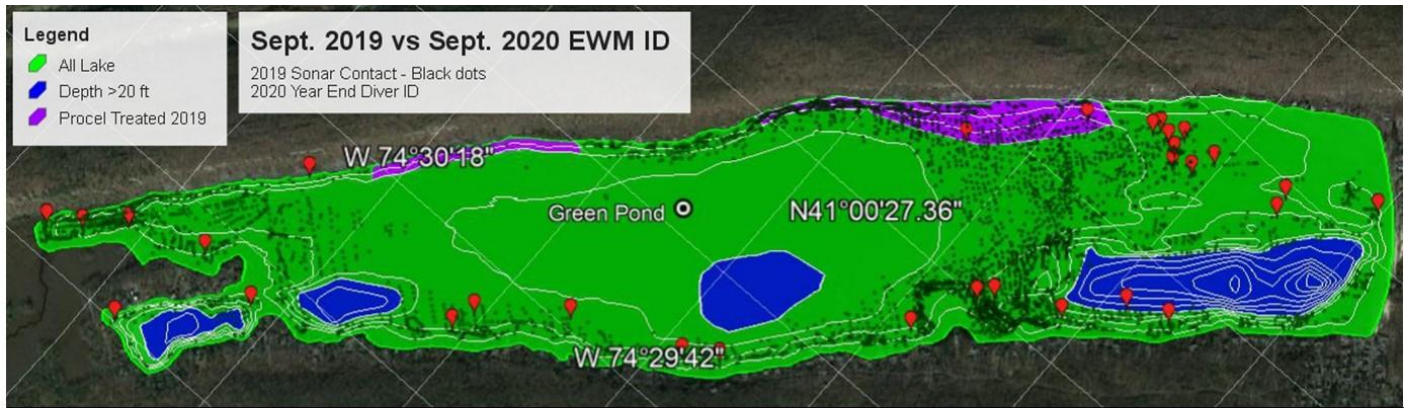
Figure 6.4 Comparison of EWM plant found in September 2019 versus 2020

While the pounds of invasive species removed was significant, the more important gauge of the Dive Team’s Search and Destroy efforts are the impacts on the presence of EWM in the lake and consequently, the level of control of EWM achieved. The impact can be understood with 2 comparisons. First, comparing 2019 to 2020 end of year’s presence of EWM finds orders of magnitude less in 2020 as shown in Figure 6.4. At the end of 2019 growing season, a sonar survey found contacts which indicated over 4,000 EWM plants. However, at the end of 2020, a combined diver and sonar survey found less than 100 plants. The second comparison is between how much EWM was removed doing the whole season which was 2,600 pounds and the equivalent of 10 pounds found in the 2020 end of year survey, again orders of magnitude difference. Both comparisons show significant reductions in EWM presence and significant control of EWM.

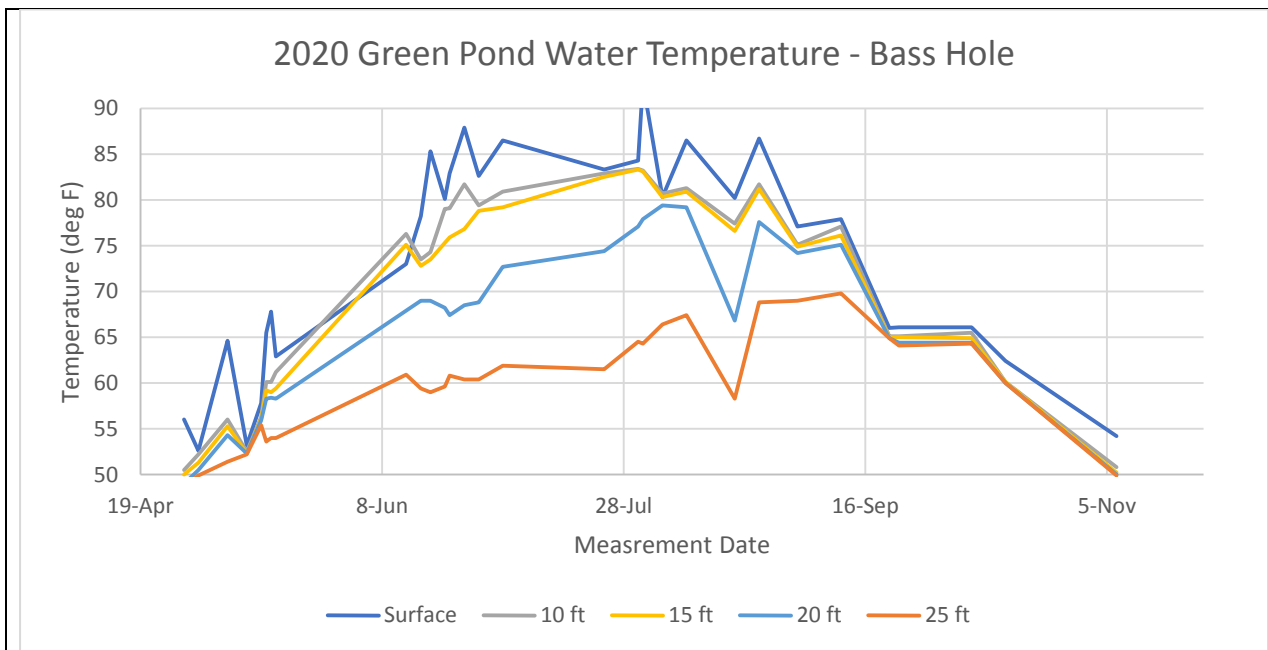
Figure PS-3 Water Temperature Profile Measurement over season. Thermal mixing caused by August storm narrowed temperature spread

**Water Column Temperature Profile over the Growing Season** Figure PS-2 shows a sample of the measurement data at the “Bass Hole” (Point 1) and Beach area (point 4) taken over the growing season. It illustrates how the surface temperature of the water fluctuates rapidly, while deeper levels require more thermal energy to warm. At the deepest level the water temperature moves very little and tracks with the ground water temperature (as shown in Figure PS-3). The 10-15 foot depths move at a more uniform rate crossing the 60 degree point on 17 May and dropping back below that level by 15 October. One notable event occurred 20 August caused “turn over”, when a storm mixed water from different depths so a net cooling occurred in shallower depths and warming occurred in deeper depths for a period of time.

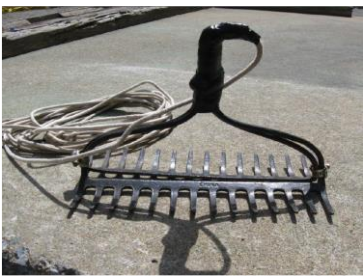
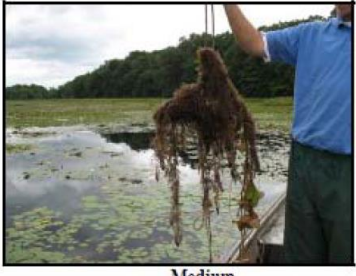
<p>Aquatic Vegetation Recovered from Each Quadrat</p>	<p>Figure BPS-3: Rake and Captured Vegetation Vegetation Level Classified as None, Sparse, Medium and Dense</p>

captured samples are then analyzed. Figure BPS-3 illustrates the process. At each of the locations a rake is tossed a calibrated distance in four directions to extract bottom vegetation and the recovered vegetation is then classified and counted to determine the relative concentration. The accuracy of the survey is determined by the number of sample points, the placement strategy (random, grid etc.). In Green Pond we have increased the number of survey points to 40 and samples are taken 3 times over the growing season. The current set of sample points was shown above.
