**Green Pond Research and Demonstration Project:
Aquatic Invasive Species Management
2021 Report**
January 6, 2021

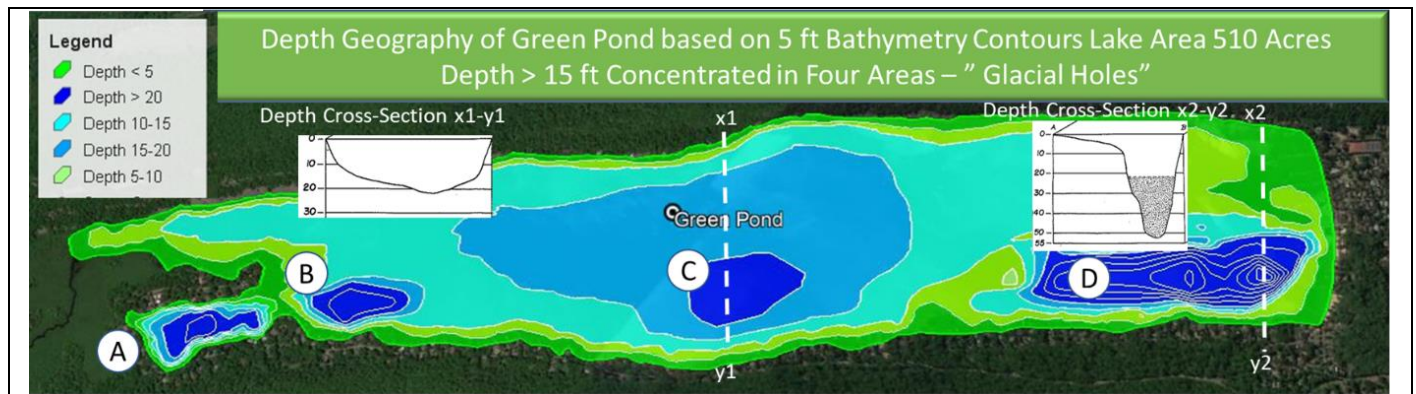
Figure 3.2: Bathymetry and depth cross sections show Green Pond's classical glacial "hole" character

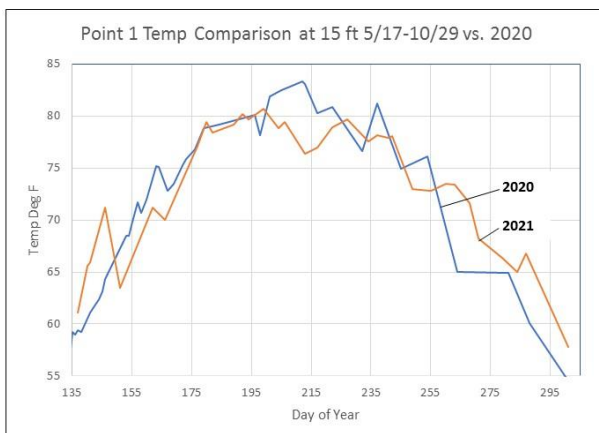
Figure 4.1 Water temperature comparisons 2021 and 2020

In reviewing the factors which could account for the differences including nutrient loading, the depth of the plants, water clarity, seasonal water temperature, and seasonal irradiance due to the number of sunny days (Gracie (1976) and Smith and Barko (1990)), one factor, water temperature, came to the fore. The 2021 growths of EWM and CLPW were the consequence of the marked difference between the cold 2020 Spring and the warmer spiking temperatures in 2021 as shown in Figure 4.1. The smaller amount of CLPW reflected the warmer water temperature which caused the plants to die off. The opposite is true of EWM which favors warmer water which was also helped by the absence of a competing CLPW early

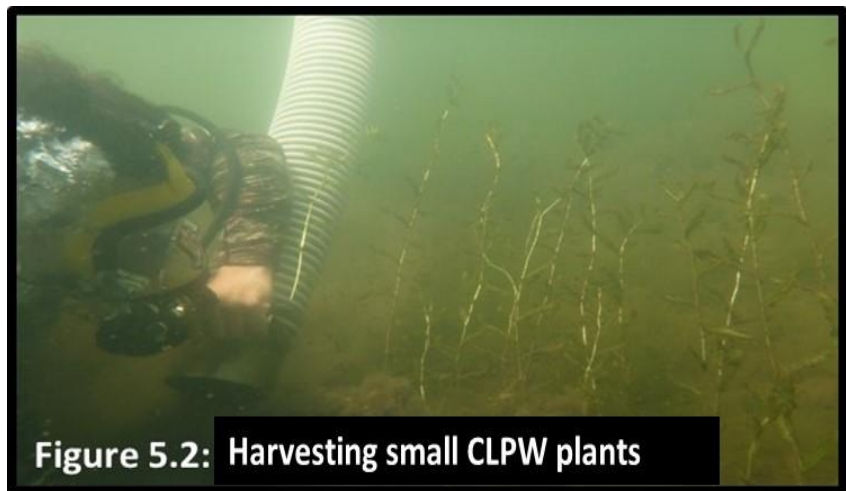
5.2.2 Destroy and Clearance Methods The main method for both Destroy and Clearance removal is hand removal assisted with ISR. Using five-inch diameter hoses attached to a Venturi system, two divers on each boat used a techniques to effectively remove invasive species found during an ISR survey. With small individual plants, the diver separates any root system from the sediment and introduces the plant into the opening of the removal hose as shown in Figure 5.2. For larger plants a similar technique was used starting at the top of the plant and following it down to a point, where the diver reaches into the sediment and pulls out larger EWM roots. Some plants could also be removed by hand, and then brought back to the removal hose floating above the benthos with buoys. These techniques along with careful removal of invasive species lead to a very small number of native plants, animals and foreign objects entering the Venturi system and minimal sediment. Anything that was brought onboard unintentionally ran back into the lake through sluice boxes or could be removed from the onion bags. Upon removing, aquatic plant material is transported by the removal hose to sluice boxes onboard and flows into 15” x 25” biodegradable onion bags. Full of plant material, these bags on average ended up weighing approximately 25 pounds.

Figure 5.2: Harvesting small CLPW plants

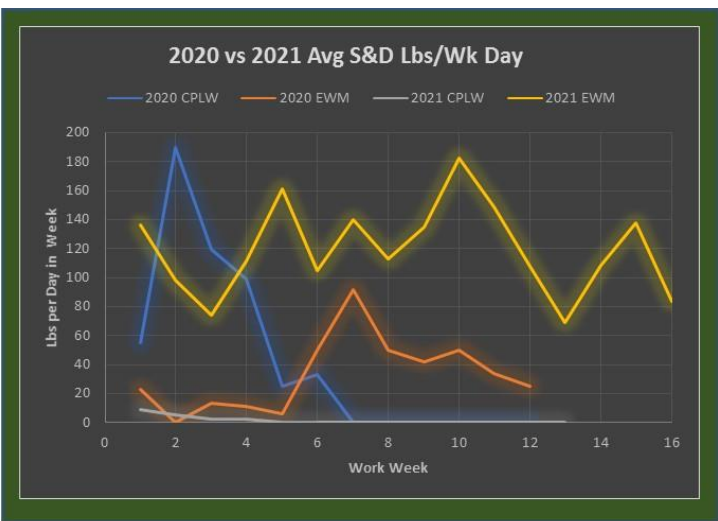
Figure 6.1 summarizes weekly EWM and CLPW removal by the Dive Team in both 2020 and 2021. It shows the daily average pounds of vegetation collected in each week of the seasons. The differences between the two years are evident from the start in both invasive species. The factor of spiking higher initial 2021 temperature substantially increased growth of the warm water loving EWM while suppressing that of the patterns of each year. In 2020, the impact of normal increasing temperatures is evident in the complementary peaking and decline of CLPW and EWM, as CLPW declines EWN increases cold water CLPW. The scope of the impact of early high temperatures is seen in the different growth. However, in 2021 from the start, there was almost no CLPW and EWM had already reached a peak and continued to peak further.

Figure 6.1 Tracking EWM Removal by Week in 2020 & 2021

The Dive Team was capable of managing the peaks created by the impact of weather. The impact of 2021 weather conditions, such as, storm events with high winds and heavy rains including two hurricanes, Elsa and Ida, are likely evident in some of the growth peaks in EWM growth pulling data. The late 2021 season behavior of EWM is indicative. In 2020, the ultimate peak happened in week 7 which started a slow decline for the rest of the season. In 2021, the ultimate peak occurred in week 10 which started a decline abruptly reversed in week 13. Hurricane IDA's strong winds and pounding rains fragmented and spread late season fragile EWM plants. The mid-August decision to extend the Dive Team operation 4 weeks into September was fortuitous. The Dive Team capped and reversed the peak preventing growth that would be carried over to the next year.

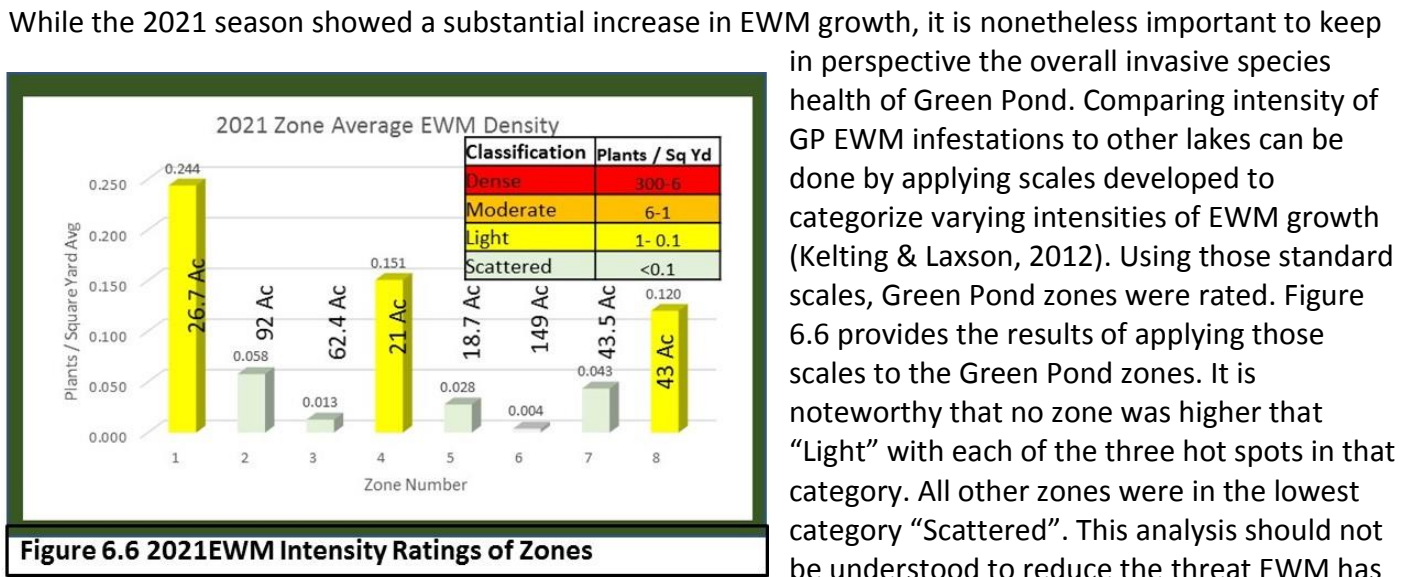
In order to complete the data picture in comparing 2020 to 2021, the level of EWM activity by zone and locations can be calculated and mapped which is summarized in Figure 6.5 below. The left side of the figure

compares the percent of each zone’s acres where EWM was present. In total, 27 acres or 6% of total acres were active in 2020 while 93 acres or 20% were active in 2021. The right side of the charts displays the locations of EWM presence aggregated into area acres. The top map shows 2021, the bottom 2020.

Figure 6.5: Comparing 2020 vs. 2021 EWM Activity Level by Zone and Location of Active Acres

for Green Pond which is great if not effectively controlled. The analysis reinforces the effectiveness of the ISR removal capability being demonstrated by this project to keep EWM from becoming a nuisance.
