# **Green Pond Demonstration Project: Aquatic Invasive Species Management 2022 Report**

**The HIGHLANDS GLACIAL LAKES INITIATIVE, Inc.  
PO Box 110 Oak Ridge, New Jersey 07438**

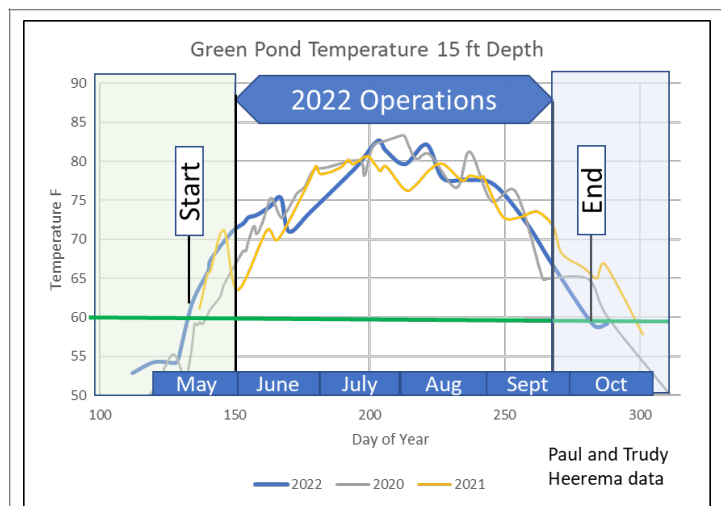
Figure3.2: In 2022 Warm Water Temperatures started earlier and dropped earlier than previous years

begins at about 50 F, stem activity in New Jersey, is generally understood to be temperature 60 degrees F at the plant roots. As shown in figure 3.2, in 2022 this was exceeded earlier in 2022, May 12 giving EWM a head-start to dominate other species. Continued warmer temperatures in the early part of the year further accelerated EWM growth.

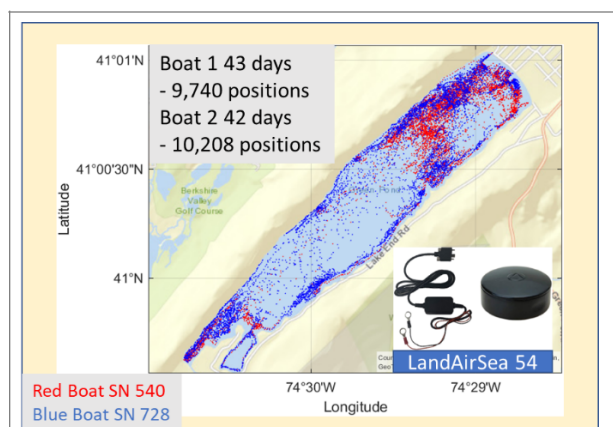
Figure 5.1: 2022 Boat Tracking Experiment

**Geo-location:** Boat tracking and geo-location was accomplished with software and devices which recorded the location of each boat continually using GPS positioning. GPS Traks on iPhone and the Lowrance Sonar with its GPS capabilities were the technologies used. However transferring the locations was a problem and the tracking process was a distraction to the boat drivers. In 2022 a high resolution, automatic and continuous boat position monitoring system was introduced to reduce operator workload. As shown in **Figure 5.1**, the units broadcast the boats GPS position over a cellular network and provides a display on a vendor web site from which the data can be download. This data was used to track the relative workload in different zones and the density of boat positions in a zone. With the tracking information they provided, quantification of the dive team's coverage of acres could happen in near real time.

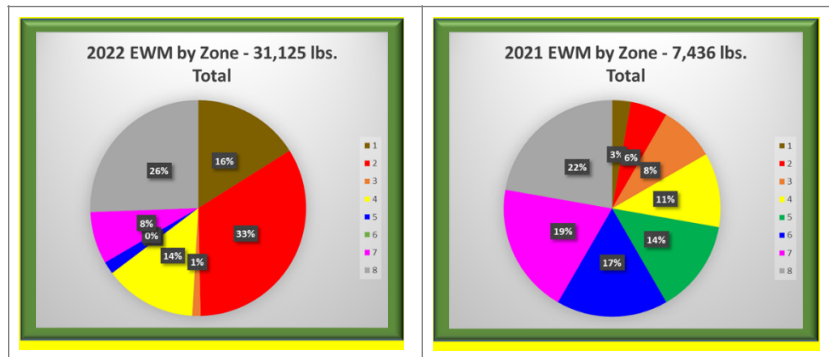
Figure 6.3: Zones 2,8,1 and 4 were largest contributors to 2022 EWM harvest. 2022 Harvest reported no zone 6 (mid-lake) harvest and small Zone 3 (West shore) contribution. Isolated Zone 5 (Outlet Cove) showed less increase than the average.

The pie charts in **Figure 6.3**, show the relative contributions of each zone to the total EWM removed for both 2022 and 2021. In 2022 there were significant increases from Zones 1 and 2 and significant relative decreases in the contributions from Zone 3, 5 and 6. Although a 2021 harvest was recorded from Zone 6, the 149-acre area in the center of the lake, no report was made in 2022. Similarly, the contribution from Zone 3, located along the West shore, decreased. Zones 3 and 6 cover 212.4 acres of which only 18.9 acres are at a depth less than 10 feet (using the reference bathymetry). Zone 5 is a deep closed cove in the South East corner of the lake, and its entrance area. Because it is closed and the prevailing winds go northward, away from the area, once cleared there is little opportunity for introduction of EWM other than by boat borne fragments. In 2022, Zone 5 EWM increased 3.3 times, lower than the average increase of 4.2 times. The depth profile is a glacial hole and most growth is at the periphery or entrance area. To understand the increase in Zones 1, 2 and 4, further analysis is presented.

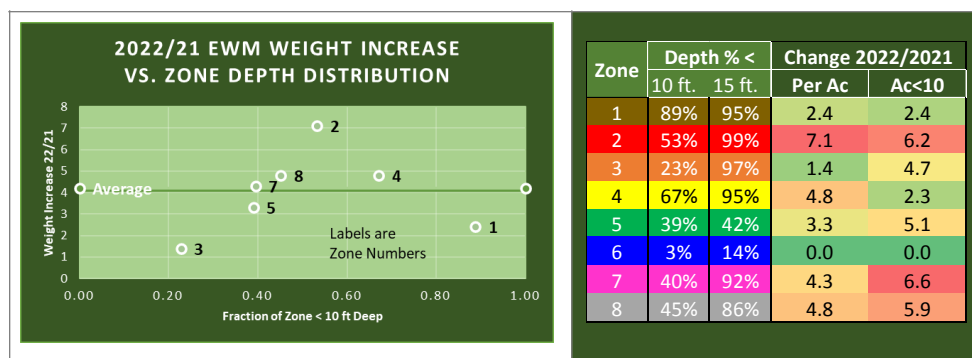
Figure 6.4 Zones Depth Profile Influences Harvest Weight Increase from 2022 to 2021. Zone 2 topography allowed 30 % increase in area less than 10 ft deep with 1 ft water drop

In 2022 the protracted drop in water level from August to October changed the growth area available to EWM. **Figure 6.4** shows the correlation between the 22/21 increase in a zone's harvest and the fraction of the zone that is less than 10 feet in depth. There is a strong correlation for zones 2,4,1. Zone 1 is already almost all below 10 ft depth and showed a 2.2-fold increase, while zone 2, with a topography that increased the area by 30 % with a 1 ft level drop, showed the largest increase. Zone 4 topography did not provide for as much EWM area increase with dropping lake depth.

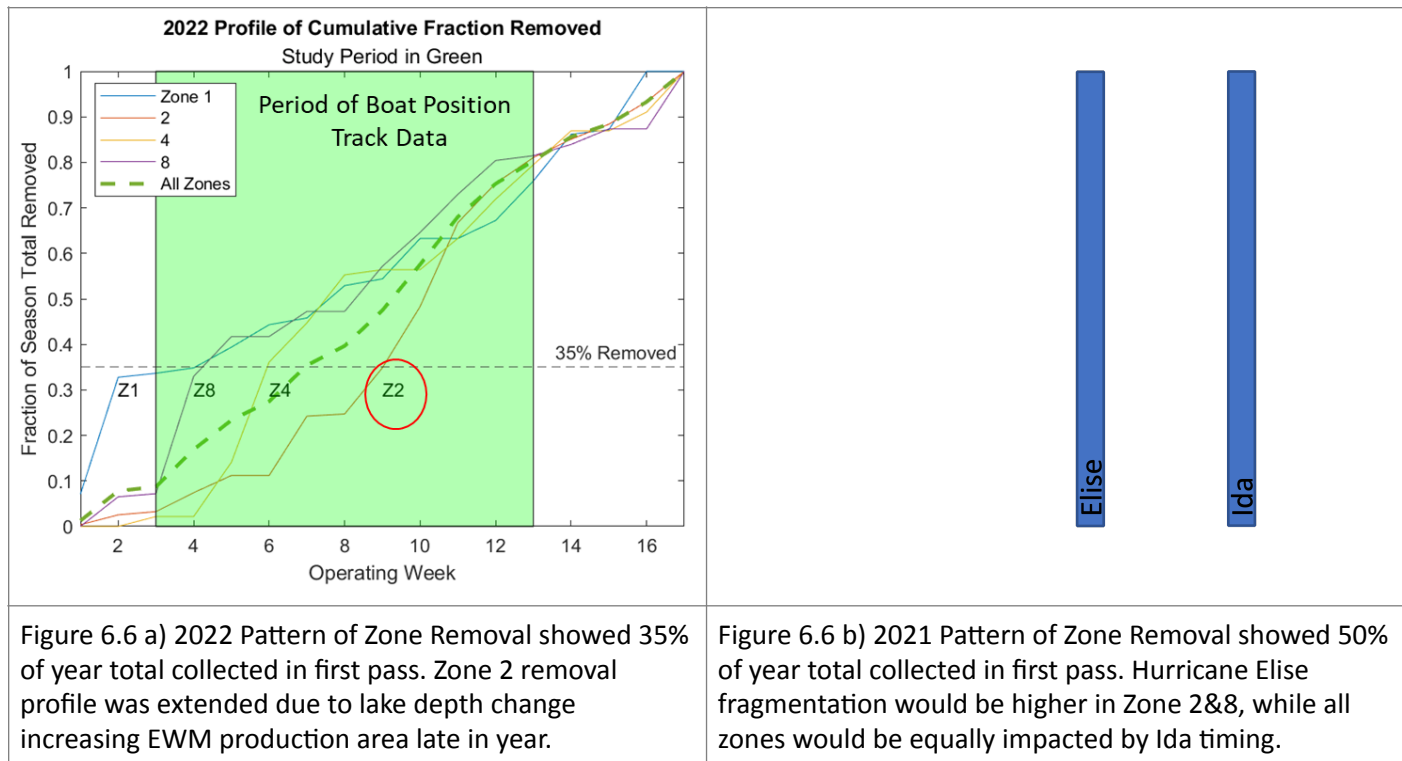
**Zone work schedule** [Figure 6.6](#) looks at when the densest areas (zones 1,2,4 and 8) produced the most harvest. The curves show how much of the total year harvest from a zone was taken by each work week.

Ideally the curve would be a step shape from 0 to 100 % with all plants cleared in the first visit. But first clearance is not perfect and plants mature at different rates across the zone. So, the characteristic is a first step followed by a line as subsequent visits clear the balance of growth. One of the advantages of zone-based analysis is seen here since the overall harvest (dashed line) appears as a single rising curve and does not give the next level of insight on the lake and operational dynamics. In 2021, the first visit typically recovered 50 % of the year’s total harvest from a zone, while in 2022 the first visit typically recovered 30%. Zone 2, which had a heavy “second harvest” due to lake level drop, had a protracted clearance. This could create additional opportunity for fragment spreading and early follow up in 2023 should be done.
